FACILITY STATUS CHANGE FORM

Date Submitted: April 2, 2013 Originator: Chris Strand Phone: 554-2720	Area: 300 Area Facility ID: 3718E and 3718G Action Memorandum: Action Memorandum #2	Control #: D4-300-034-1
--	---	-----------------------------------

3718E AND 3718G
FACILITY COMPLETION

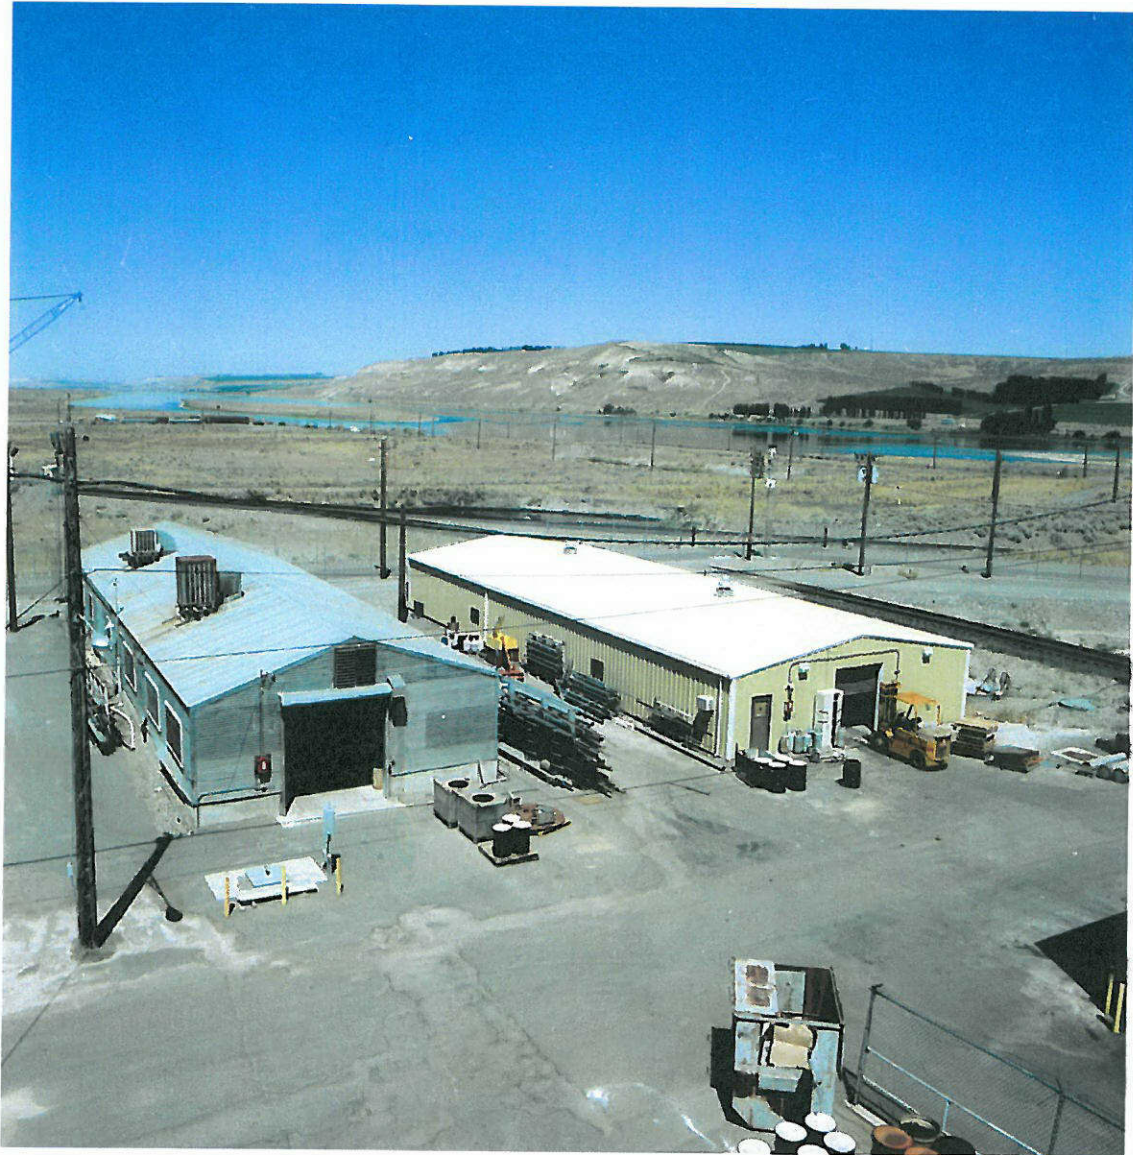
**Photograph 1: 3718E (left) and 3718G (right) Buildings,
looking north, July 26, 1985.**

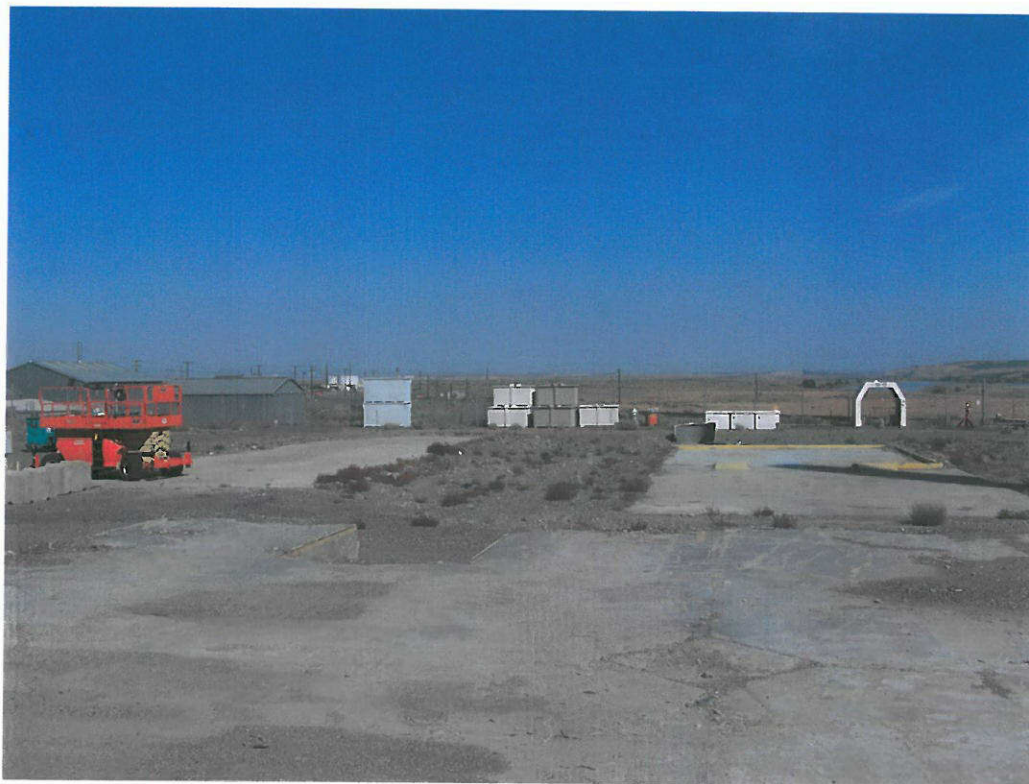
**Photograph 2. 3718E (left) and 3718G (right) slabs,
looking north on September 16, 2009.**

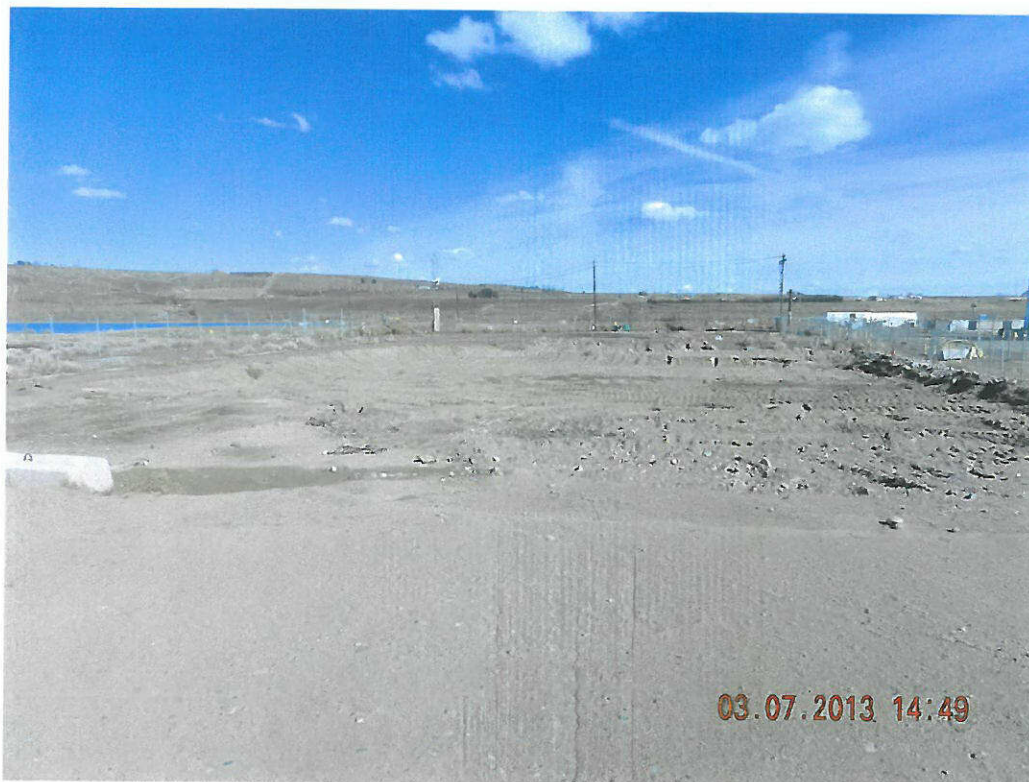
Photograph 3. 3718E and 3718G common excavation looking east, March 7, 2013.

No anomalies were discovered during slab removal. However, an asphalt apron was encountered approximately two feet below both slabs. The asphalt was left in place.

Soils beneath the slab and foundation displayed no visual evidence of staining or discoloration. A final GPERS survey of the excavation following below-grade demolition identified no radiological contamination.

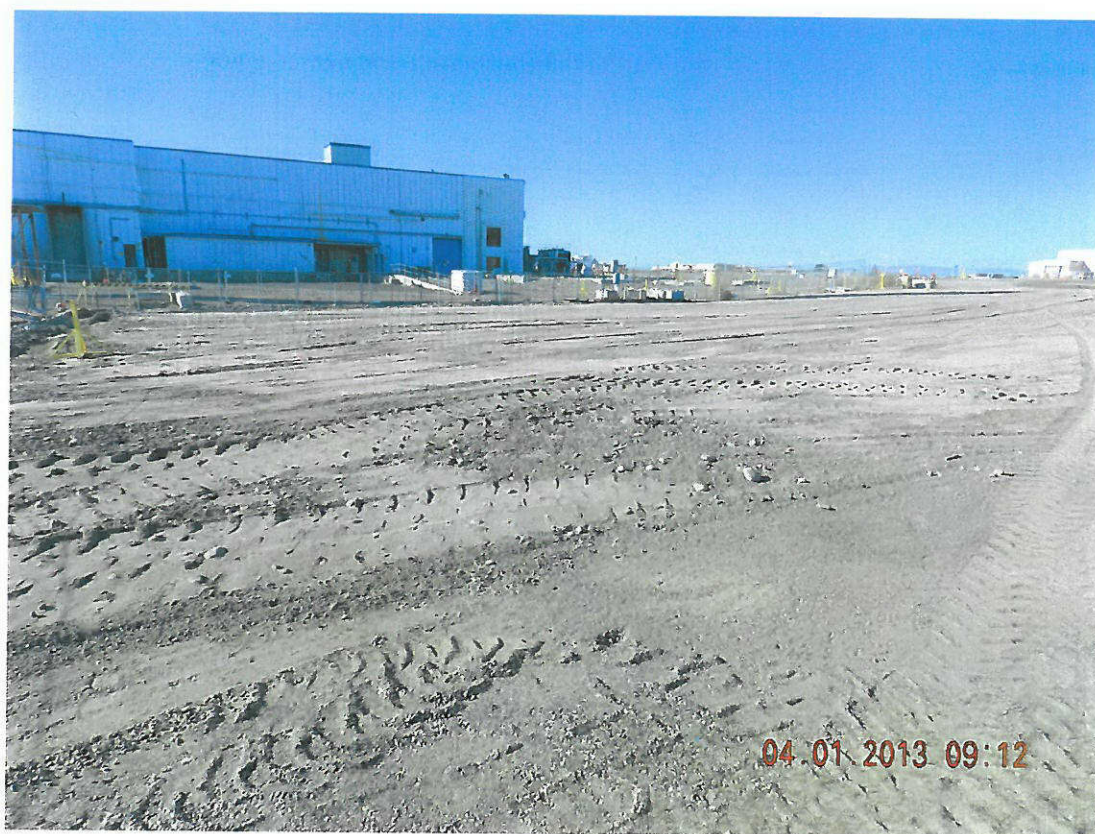
**Photograph 4. 3718E and 3718G site backfilled, looking southwest
on April 1, 2013.**

All above-grade structures and foundations were removed. Excavations were backfilled to grade with clean fill. GPERS surveys were performed prior to backfill. No radiological or Industrial Hygiene postings remain.

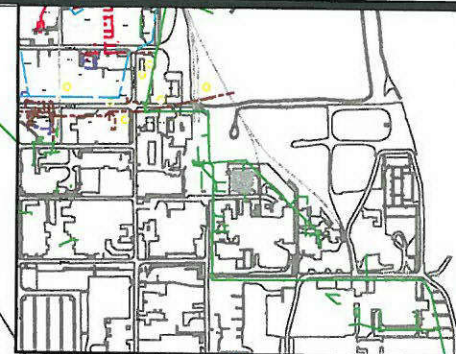
300 D4 3718E, G Slab GPERS Radiological Survey Beta Track Map

Coverage File: DD4085.A
Number of Data Pnts: 308
Type of Survey: beta
Max GCPM: 637
Avg Bkg CPM: 281
Survey Date: 3/26/2013
Area Surveyed: 1,120 m²
Project File: ESRFRM130033B
Pdf File: ESRFRM130033BC

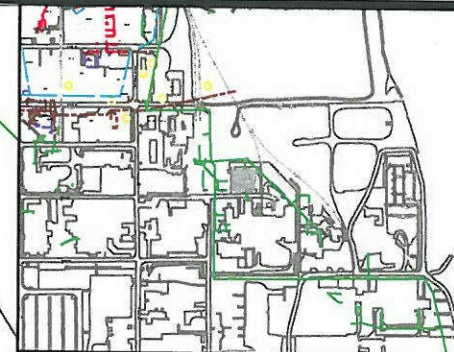
300 D4 3718E, G Slab GPERS Radiological Survey Gamma Track Map

Coverage File: DD4085.A
Number of Data Pnts: 4248
Type of Survey: gamma
Max GCPM: 1984
Avg Bkg CPM: 1261
Survey Date: 3/26/2013
Area Surveyed: 1,120 m²
Project File: ESRFRM130033G
Pdf File: ESRFRM130033GC
